## Vehicle History Report

### CHRYSLER 300C 2014

**2C3CCABG5EH377726**

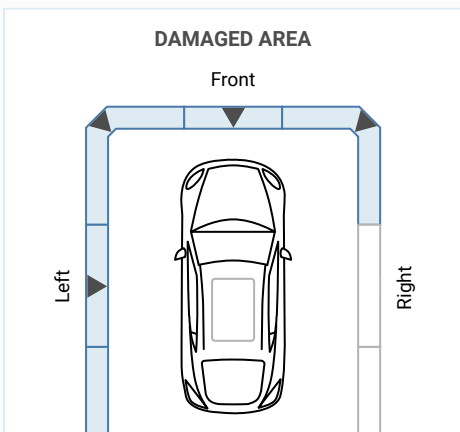
2019-08-27 Damage reported

**Damaged area:**

- Front
- Left
- Left front
- Left rear
- Right front

**Estimated repair costs:**  
PLN 29,000 - PLN 30,000

**Damaged components:**

- Body parts
- Windshield / Glass
- Upholstery

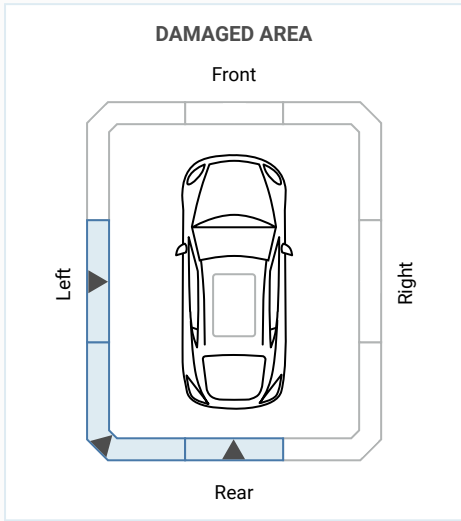
### 2024-03-04 Damage reported

**Damaged area:**

- Left
- Left rear
- Rear

**Estimated repair costs:**

PLN 5,000 - PLN 6,000

**Damaged components:**

- Body parts
